CLOSED WASTE SITE
EVALUATION
EMSDALE LANDFILL

OCTOBER 1989

Report prepared for:
Waste Site Evaluation Unit
Waste Management Branch

Report prepared by:
Morrison Beatty Limited

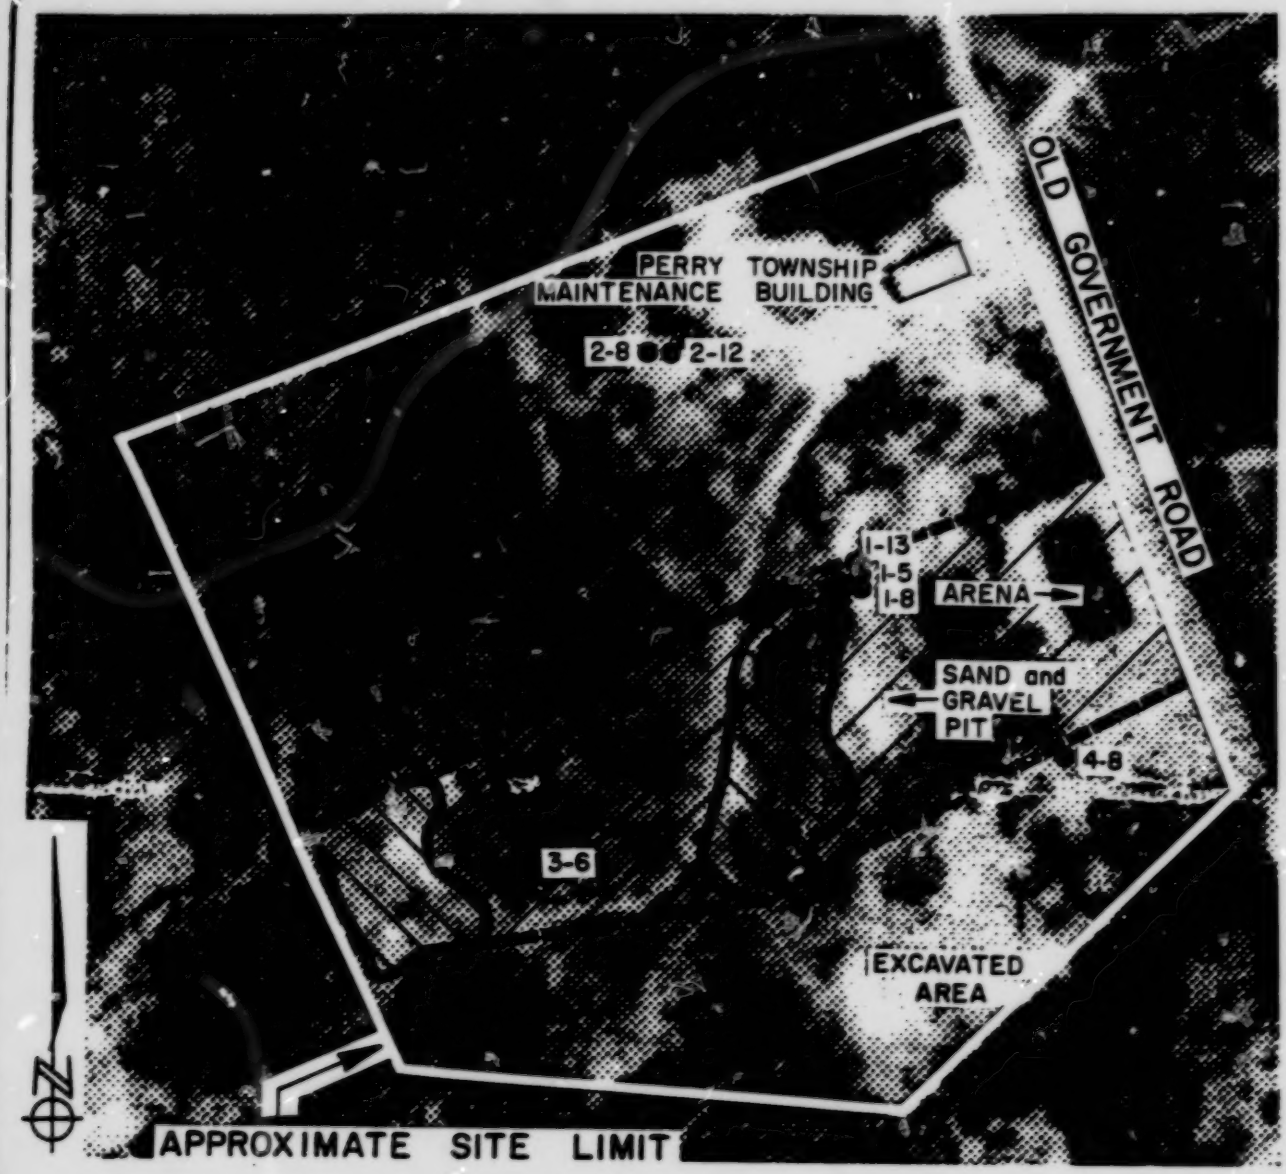
As previously noted, wastes from a 1972 train derailment at Novar were disposed of at the Emsdale site under MoE supervision. The location of the train derailment wastes was difficult to determine because no documentation exists. Test pitting during the Phase I and II studies identified the general area where caustic soda and other chemicals were placed in a trench and subsequently covered. The disposal area currently is covered with waste brush and stumps. Figure 5 shows the approximate limits of the derailment waste.

During both the test pitting and test drilling, no specific evidence of the derailment wastes was observed. The location of the waste is based on visual inspection of a pit side in the area where the wastes were reportedly encountered during gravel extraction. At present, the area is isolated from the gravel pit by windrows of gravel, concrete, and waste asphalt.

To ensure on-site safety, the derailment waste area should be clearly identified and secured with fencing. The east side of the area, in the gravel/sand pit, should be backfilled to ensure the pit wall is stable from either natural or man-induced slope failure.

2. The area at the east side of the waste pile in the adjacent sand/gravel pit should be stabilized against potential slope failures. This can be done by backfilling to original ground surface and maintaining a slope less than the natural angle of repose for the backfill. The existing cover on the derailment wastes should be reshaped to shed water.

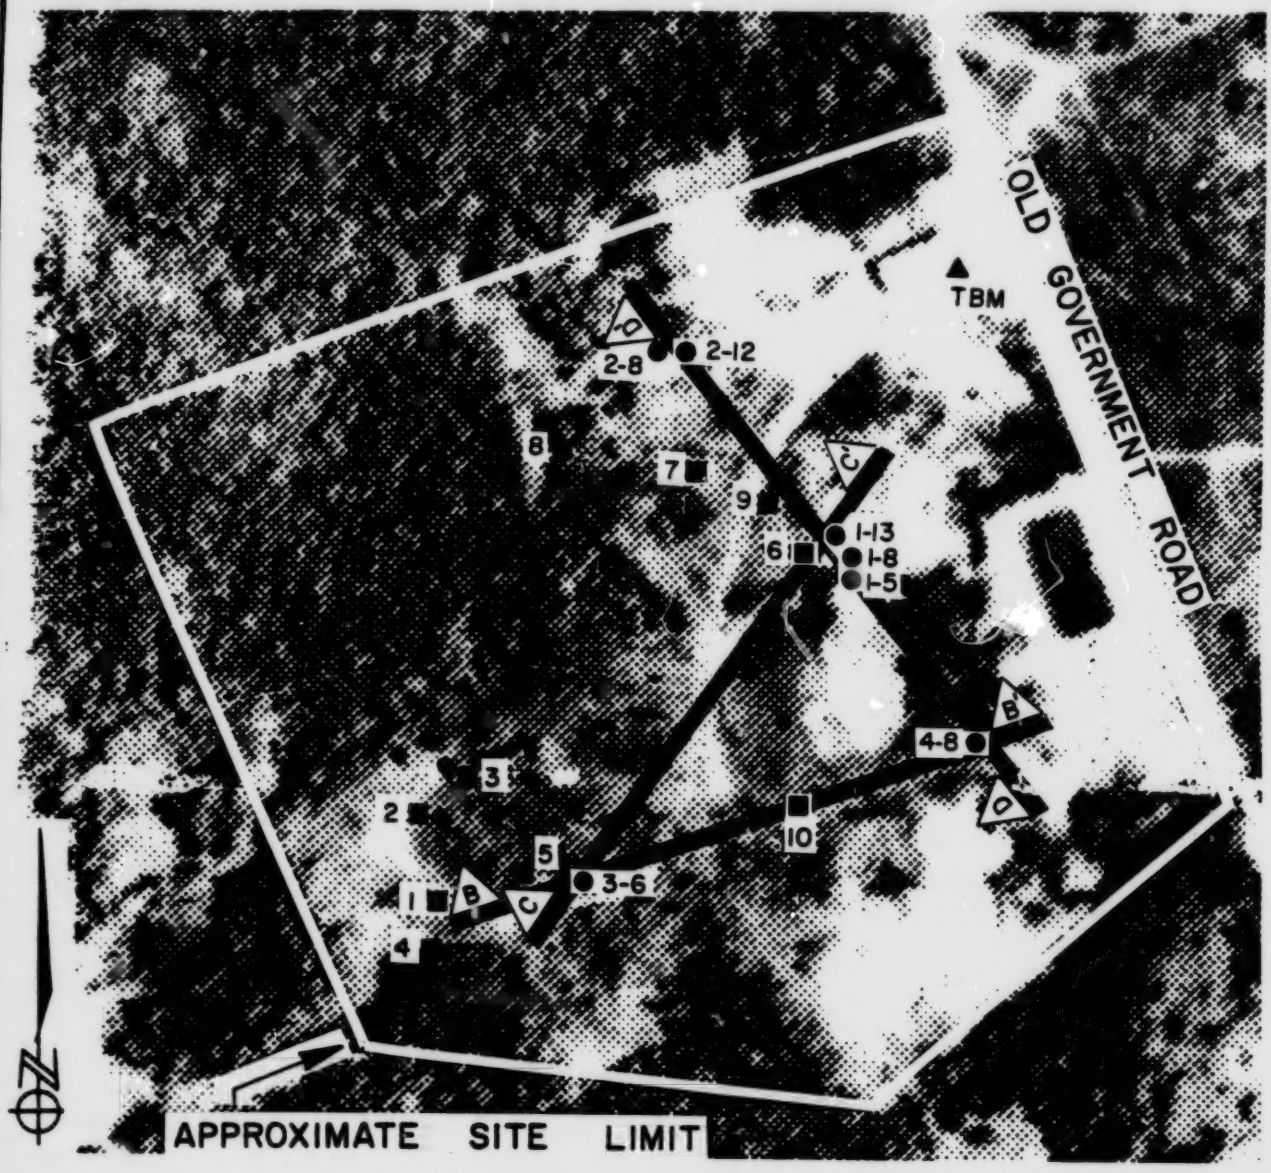
In OW 1-13, the deepest well immediately downgradient from the derailment wastes, the levels of typical leachate indicators were not elevated. However, slightly elevated fluoride, chloride, phosphate and pH levels were noted in OW 1-5, the shallowest well in the nest. Although levels are well within the MoE Drinking Water Objectives (DWO), these parameters are above local background conditions. Table 1 presents a comparison of on-site groundwater quality and DWO.

At the OW 2 nest and at OW 4-8, no evidence of contamination was observed. Levels of typical leachate indicators are at or below DWO levels and the water quality is considered representative of background conditions.

At present, the effects from the landfill are limited to areas immediately downgradient of the waste pile. At the site boundary monitoring (OW 4-8) shows that groundwater quality is similar to background conditions (OW 2 nest). Therefore private water supply wells located further downgradient are likely not affected by the landfill.
